Strengthening of fire damaged, light weight, high strength reinforced concrete beam using SIFCON jacket

Ahmed Habeeb Albo Sabar¹, Mohammed Mansour Kadhum²

¹ Civil Engineering Department, College of Engineering, Babylon University, Babylon, Iraq.

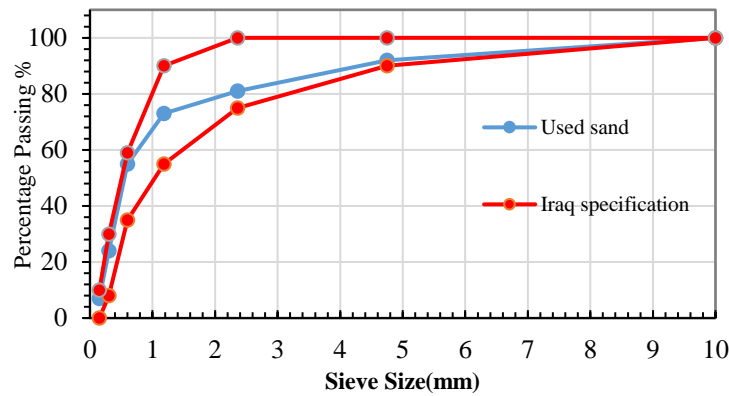
Figure 2. Grading curves for fine aggregate compared in accordance with (IQS NO.45/1984, Zone 2)

Natural sand from local resource, which was supplied from Kerbala, has been utilized as a fine aggregate in the main concrete mixture. The size of the sand used in SIFCON slurry very important; it must be small enough to guarantee thorough penetration into the thick steel fiber without causing clogging. In the preparation of SIFCON slurry, only the fine sand which was sieved through (1.18 mm sieve) to filter the coarser particles can used during the experimental work for all SIFCON mixtures. Table (3-3) shows the sieve analysis of the sand used. It conforms to the limits of Iraq specification No. 45/1984 Zone (2). Figure (1) shows the grading curve of the natural sand in accordance with (IQS No. 45/1984), and the physical and chemical properties of natural sand are illustrated in Table (3-4).

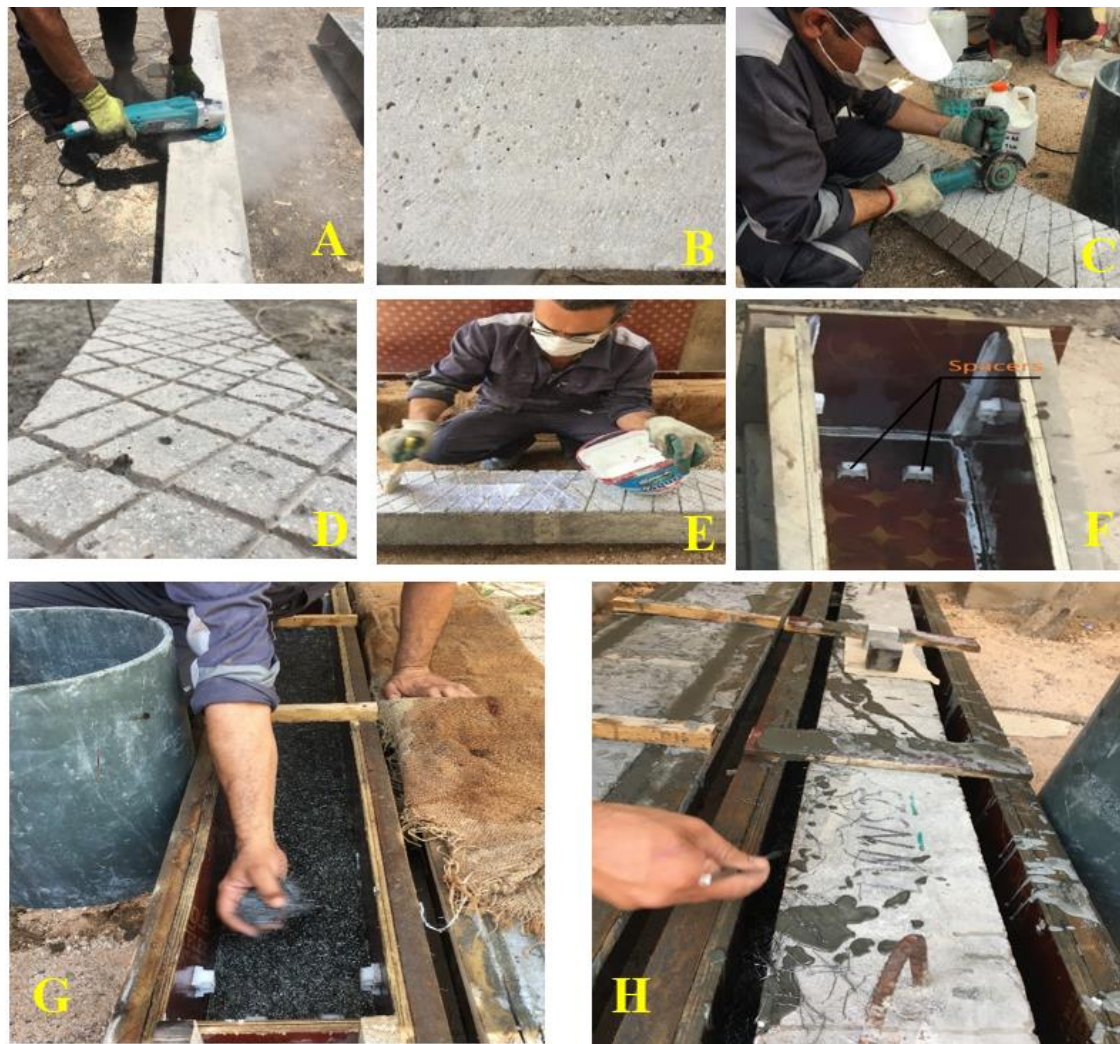
- 1 •The surfaces of fire-damaged LWC beams should not contain microcracks. The badly affected portions of LWC beams removed, which are roughly thickness of 10 to 15 mm.

- 2 •The surface of specimen was cleaned thoroughly by water and then by compressed air to ensure no dust
- 3 •To increase the binding between the LWC beams and the SIFCON jacket, the faces of the fire-damaged LWC beams were roughened with a special tool.

- 4 •To achieve perfect bond strength, the beam surfaces were coated with SBR bonding agent layer.
- 5 •The mold was lubricated before laying of steel fiber of the underside layer of jacket.

- 6 •Positioning of the beam inside mold above the underside layer and pouring the lateral side of jacket.
- 7 •After 24 hours of casting, the strengthened beam been taken out the mold, and then cured for 28 days with wet burlap. This was achieved by putting the beams upside-down in order to prevent curing of the original concrete.

- 8 •Prepare the strengthened beams for loading test

Figure 9. Process of strengthening the fire damaged LWC beam specimens

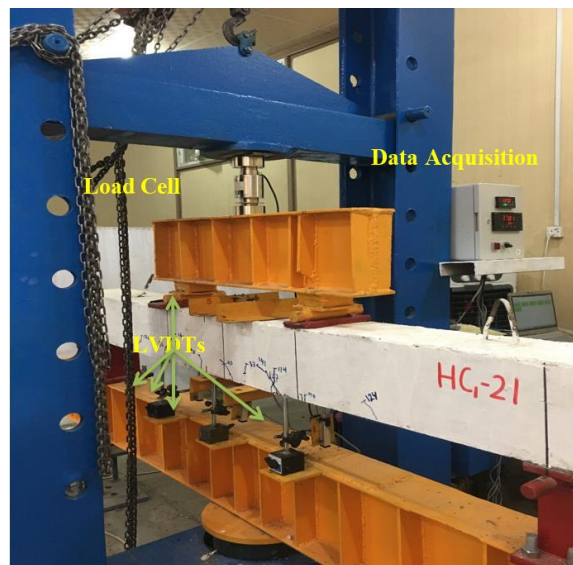
Figure 10. Arrangement of LVDTs and Load Cell within the test device

The beam specimen surface was usually cleaned and coated with white emulsion before testing to clarify cracks propagation and make cracks observation easier. The beam specimen was then positioned in its testing position, and the LVDT were set in their locations. A steel beam was used to apply and divide the load at two locations, dividing the tested LWC beam into three parts to create a nearly equal load applied to the LWC beam. The distance between two-point load was 800 mm. bearing plates were made from hardened steel with dimension of (210×75×20) mm to sustain the applied load avoiding crushing in the contact point of specimen body that may influencing the test, the supports were designed to function as a hinge support from one end and a roller support from the other. The load was applied to all beams using a hydraulic testing machine with a capacity of 600kN. Beams were subjected to monotonic increasing load tests until they failed. five LVDT were set to measure the displacement in different location along the beam specimen, the first LVDT placed at the bottom surface of the beam's middle point and two LVDT placed under the two-point loading. The mid-span curvature obtained from other two LVDTs placed along the top and bottom fibers and measuring displacement changes over a distance of 20 cm. Figure (10) illustrates the mechanical loading configurations and sensors locations.

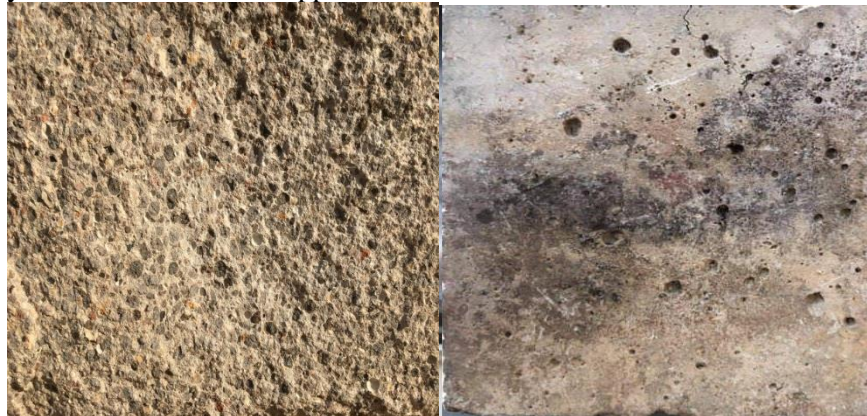
Figure 12. Speckle pattern of tested beam, A- Specimen surface enlarged image, B- Partial enlarge hairline cracks

The beams specimens after they have been exposed to fire. The color of the surfaces exposed to fire was light gray with some light reddish areas. On the exposed surfaces, tiny reticular cracks occurred., as shown in Figure (12). Random tiny cracks line of varying widths (0.04–0.18) mm were seen on surfaces after exposure to high temperatures up to 600 C for 1 hr. The most significant cracks were found near the primary and transverse reinforcing points on the concrete surface. These cracks could be caused by the RC element expanding, causing large tensile strains in the concrete, particularly at the reinforcing contact, and the cement matrix and aggregate responding differently to high temperatures.

Furthermore, concrete spalling occurred on the beam's corner without exposing any steel, with a maximum spalling depth of nearly 15 mm. However, no apparent beam curvature was detected.

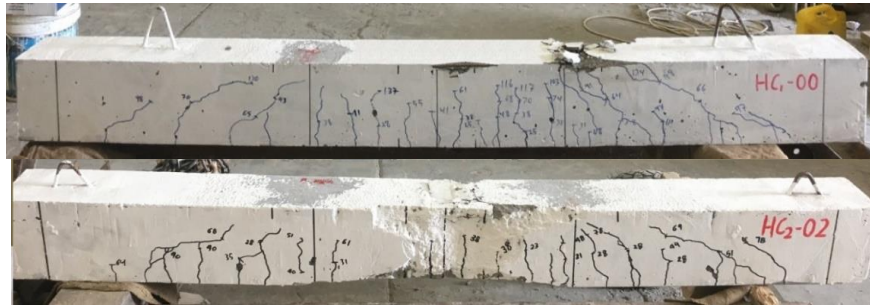
Figure 13. Cracks pattern of HSC LWC beams before and after burning

The specimen beams without strengthening appeared an initial flexural crack at the midspan of the specimen., the first crack appear in the bending zone about 10 cm. from the left of load applying point. As the applied load was increased gradually a number of cracks appeared in the left of first crack heading vertically, later diagonal cracks formed and propagated along the distance between the supporting and load applying points. Figure (13) shows that the inclination angle of diagonal cracks becomes bigger after burning, the cracks extension shorter, and number of cracks was less after burning. a/d ratios greater than 2.5, in which case the failure is induced by a diagonal crack beginning located at the top of the flexural crack next to the support. the shear tension was the failure mode. in the case of (HC2-02) specimen beam, where the crack resulting in loss of bonding, while it seems to be shear compression failure in the case of (HC1-00) specimen beam as a result of crushing of concrete at the loading point.

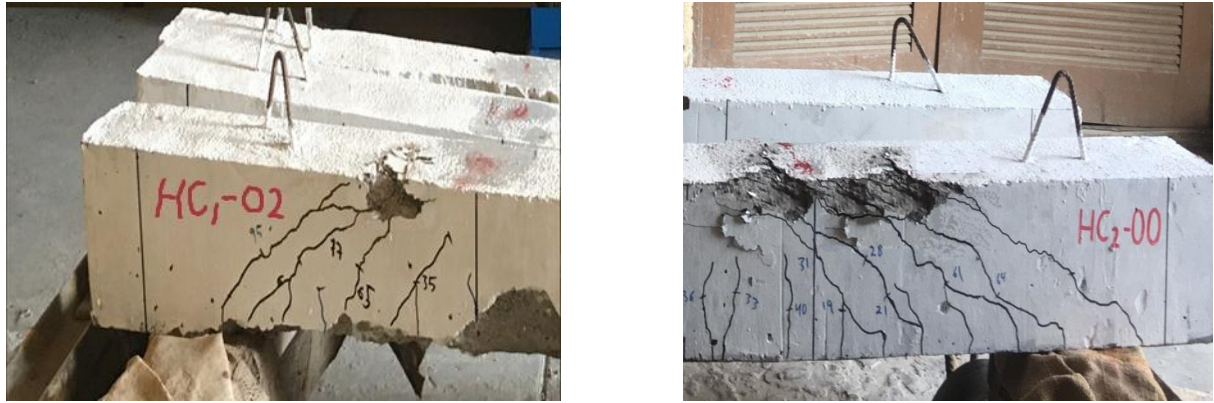
Figure 17. Failure of beam without strengthening of SIFCON jacket

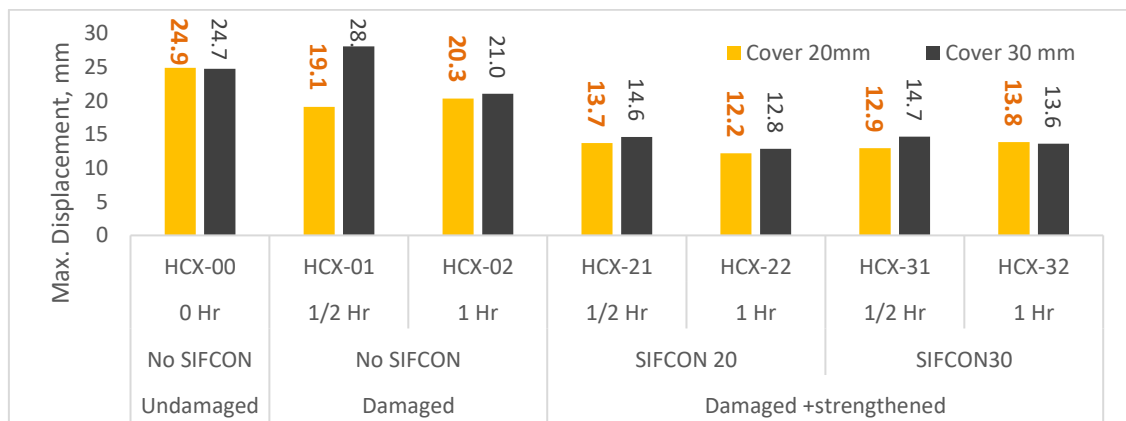
Figure 18. Mid-span displacement corresponded to the maximum load carrying values

For the maximum mid-span deflection (MMSD) corresponded to the maximum LCC, as presented in Figure (18), applying 1 hr. fire exposure duration resulted in reducing MMSD value by about 18.5%, for both of the used covers. After strengthening, beams with 20 and 30 mm SIFCON layer thickness reflected lower MMSD value by about 40% and 32%, respectively. which means, increasing SIFCON layer thickness by 10 mm resulted in reducing MMSD value by about 8%. Table (7) shows beam’s deflections at different locations and for various conditions.

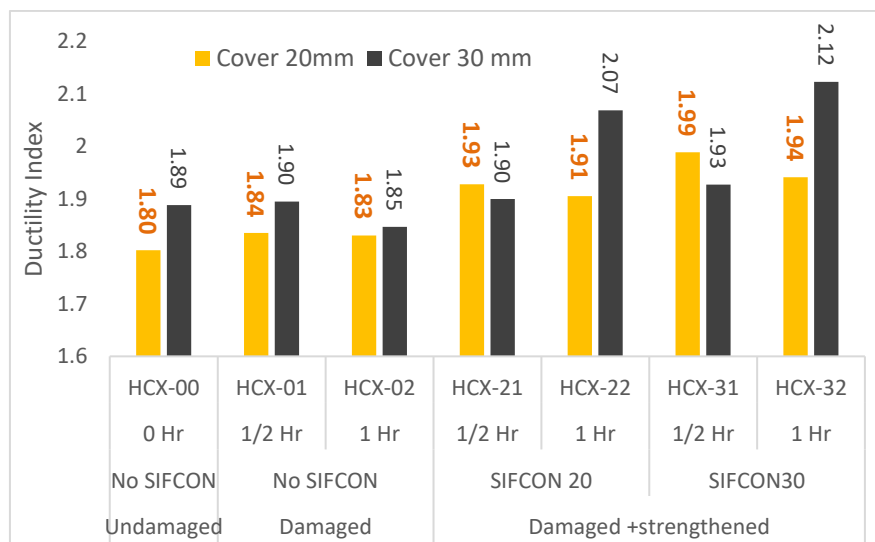
Figure 22. Initial stiffness results of beams before and after fire exposure and strengthening

The results of beams show that the ductility index not effected by burning. On the contrary, a slight increase was observed. Where for beams that exposed to (0.5 hr.) with concrete cover (20 and 30 mm) shows increase in ductility index of (1.8% and 0.37%) and increase (1.6%) for cover 20mm and decrease of (2.17%) after exposed to (1.0 hr.). The results of ductility index were between 1.717 and 2.284 for the tested beam specimens before and after burning. The experimental results have cleared that a 1 hour fire damage has a negligible effect on the ductility index, for both concrete covers. While strengthening of damaged beam resulted in improving the ductility index by about 5% and 14% for beam with 20 mm and 30 mm concrete cover, respectively compared with the unstrengthen members. On the other hand, the ductility index was enhanced by about 14% and 11% for 20 and 30 mm concrete cover, respectively when comparing the strengthened beams with the undamaged (reference) beam, as can be seen in Figure (22).

Overall , The Experimental results have cleared that a 1 hour fire damage has a negligible effect on the ductility index, for both concrete covers. While strengthening of damaged beam resulted in improving the ductility index by about 5% and 14% for beam with 20 mm and 30 mm concrete cover, respectively compared with the unstrengthen members. On the other hand, the ductility index was enhanced by about 14% and 11% for 20 and 30 mm concrete cover, respectively when comparing the strengthened beams with the undamaged (reference) beam. Table (10) presents the results of yield deflection, ultimate deflection, and the ductility index values of specimens under various conditions.
