Experimental study on repair of cracked pipe under internal pressure

Ali Abduljabbar¹, Haider Khazal², Abdul Kareem F. Hassan³

^{1,2,3}Mechanical Department, Engineering college, University of Basrah, Iraq

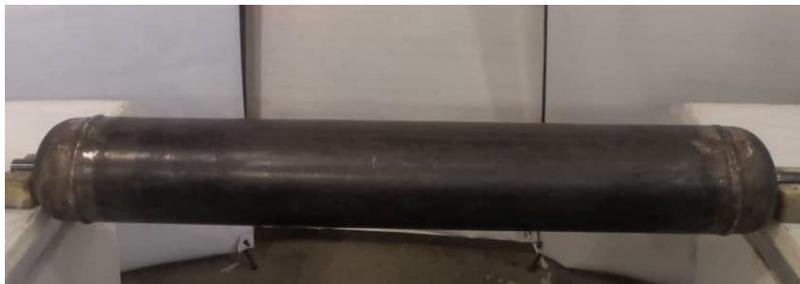
To do the tests, containers assembled from 1 m pipes and caps as depicted in Figure 2. Schedule 40 steel pipes with outer diameter 168.3 mm and 7.1 mm thickness, and endcaps with 10 mm thickness with full penetration groove welds were used, as depicted in Figure 3.

Figure 2. The vessels used for internal pressure tests

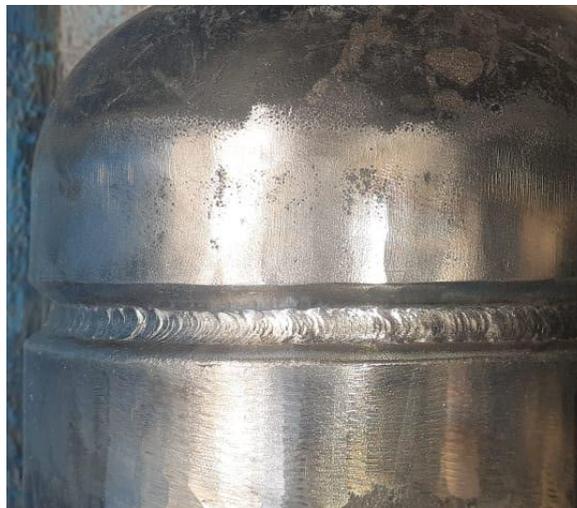
Figure 3. Details of end-cap and connection to the pipes

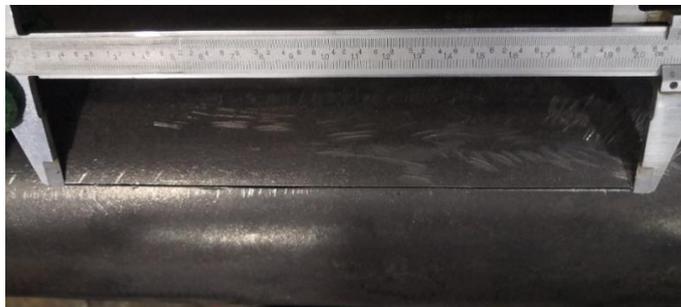
A crack with 210 mm length and 4.6 mm depth were applied in the centre of vessel in longitudinal direction as depicted in Figure 5. Accordingly, the remaining thickness of the pipe is 2.5 mm that is corresponding to the 35% of the initial thickness. The opening of the crack is 0.4 mm.

Figure 5. Longitudinal crack with 210mm length and 4.6mm depth considered as defect in central part of the vessel

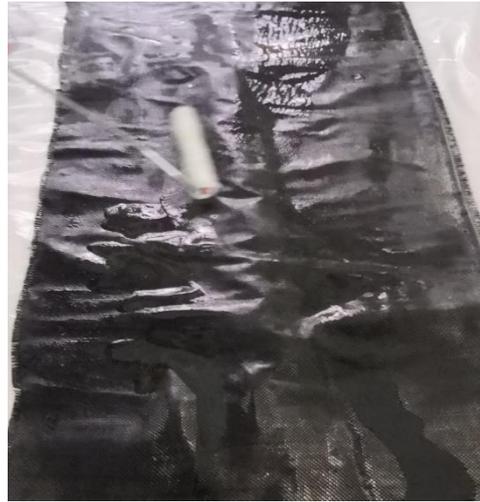
For repair system, woven fabric of CFRP were used. Totally 6 layer CFRP with 3 mm thickness and 500 mm width were considered to repair the pipe. The carbon fabric was impregnated with the epoxy resin (Figure 6), and then wrapped around the vessel (Figure 7). Material properties of carbon fibers are as described in Table 1. It should be noted that the surface of pipe roughened before wrapping the FRP. Due to the very thin width of the crack, no putty was used before applying the CFRP. However, sharp external corners of cracks were rounded to avoid cutting the CFRP during the test, and crack opening were filled with low viscosity epoxy polymer. Epoxy polymer was allowed to cure for 24 hours at room temperature after the repair process was completed before being tested.

Figure 6. Saturation of carbon fabric with epoxy resin

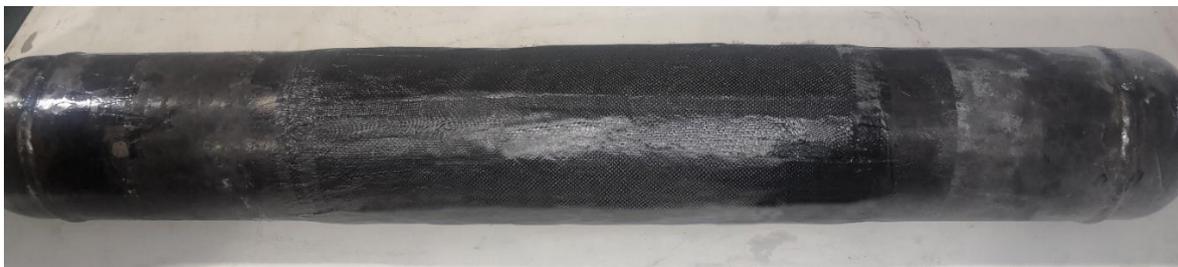
Figure 7. Repaired vessel with carbon epoxy

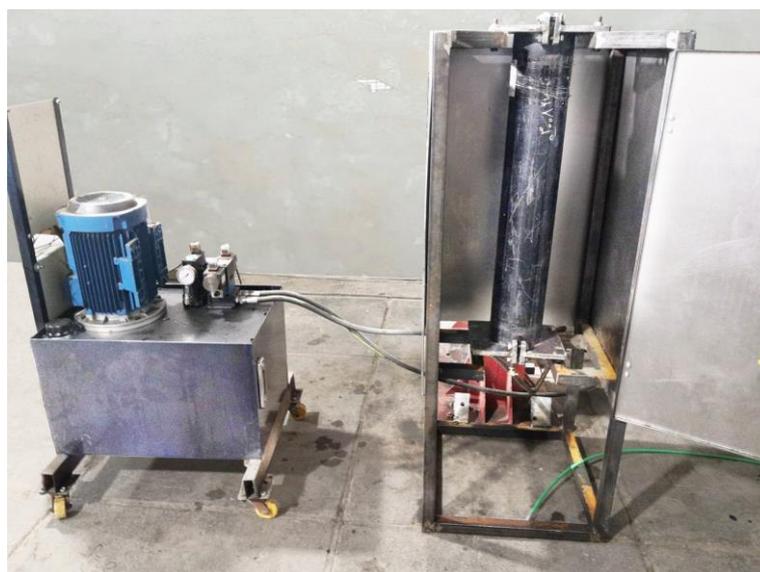
Figure 8 shows the setup that was used to do the internal pressure test. The Vessel filled with water, and after that, a hydraulic pump was used to apply internal pressure. The pressure increased up to the failure pressure.

Figure 8. Setup for doing internal pressure tests

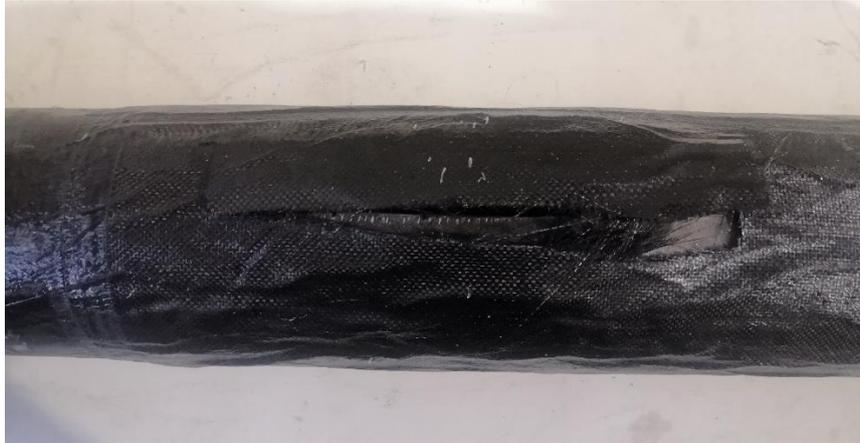
As discussed in the previous section, internal pressure increased in the vessel up to the failure point. 255bar pressure was recorded during the test. Figure 14 shows the ruptured vessel after finishing the test. It is clear

from this picture that the rupture occurred in carbon fibers, and additionally a delamination between pipe and CFRP is seen around the crack. Delamination around the crack is due to the high-water pressure injected between pipe and CFRP.

Figure 14. Situation of pipe after burst test

Failure pressure of the vessel with 3 mm composite thickness was obtained 25.5MPa according to the experimental test. Clearly, comparing experimental results for failure pressure and ASME for design pressure shows the recommended relation for composite repair in crack condition is not safe. It can be attributed to the stress concentration in crack condition that should be considered in strengthening of the cracked pipes.

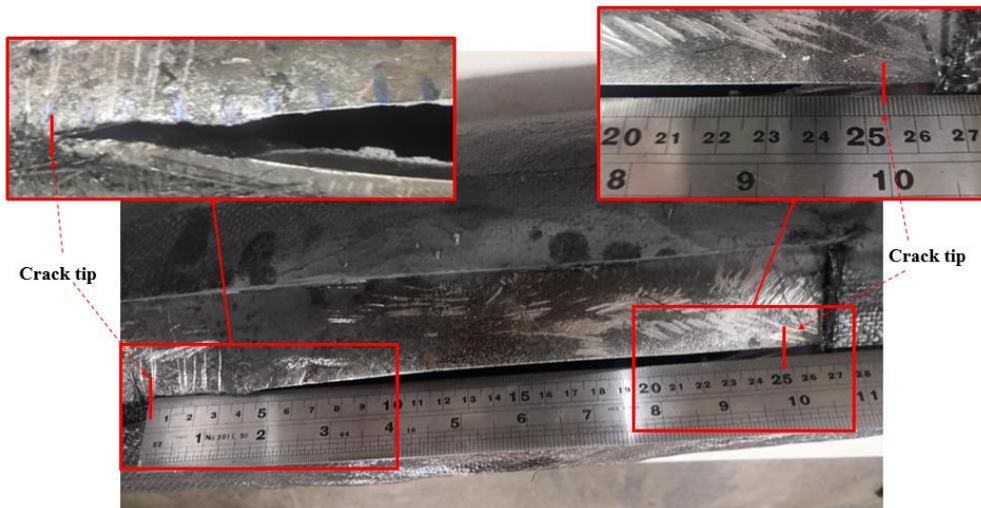
Figure 15 shows situation of crack after rupture. As can be seen in this figure, the crack length increased to 254 mm.

Figure 15. Crack propagation in steel pipe after rupture
