GIS risk analysis of a first-degree seismic zone: Kaynaşlı (Turkey)

ABSTRACT

This study aimed to analyze the land survey maps and existing data to determine the vulnerable areas of the Kaynaşlı districts at risk in terms of natural disaster, as Kaynaşlı is located in a first-degree seismic zone. This three-phase study analyzed geological-geotechnical survey reports via the geographic information system (GIS) and applied them to Kaynaşlı Municipality in Düzce Province (Turkey). First, a non-digital raster suitability map based on a 2005 Kaynaşlı Municipality report was digitized via ArcGIS and used to conduct natural disaster risk analyses of Kaynaşlı. The 2112 buildings covered by the suitability map were then scanned and inventory information generated for each. Finally, using ArcGIS software, the digitized inventory information was superimposed on the suitability map. In Kaynaşlı, a total 2112 buildings were examined via street screening and their risk status was identified in terms of the terrain. Disaster and risk ratios were calculated and vulnerable areas were pinpointed. All the information obtained from the results of the analyses was shared with the local authorities. Ac

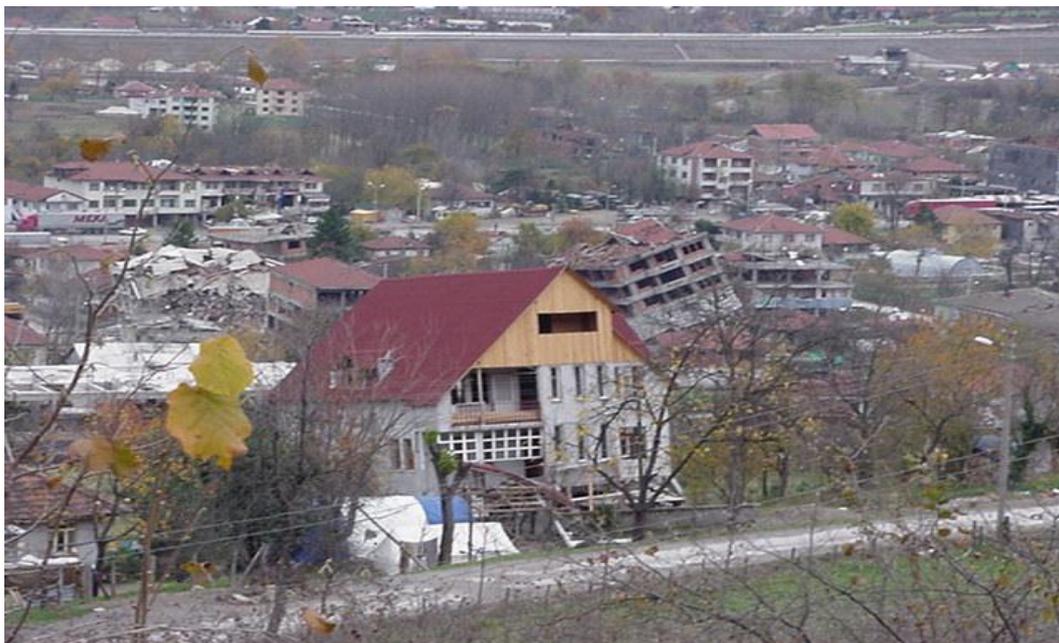
Figure 2. Destruction in Merkez District, Kaynaşlı, after the 12 November 1999 earthquake [14]

Figure 2 shows the heavy destruction that occurred during the devastating Kaynaşlı earthquake. Some of the buildings were completely destroyed, while others were left leaning. Most of the collapsed structures consisted of high-rise buildings. Since the earthquake, the number of floors has been restricted to three as per the implemented reconstruction plan, and except for certain districts, detached (discrete) structures are now mandatory.

According to the Earthquake Assessment Study of the Ministry of Environment and Urban Planning dated 21 December 1999, most of the devastation seen as a result of the 12 November earthquake occurred in the

Merkez District of Kaynaşlı (Fig. 2). The total damage assessment study of the Ministry showed that 840 of the 1457 heavily damaged or demolished buildings were located in the Merkez District [15].

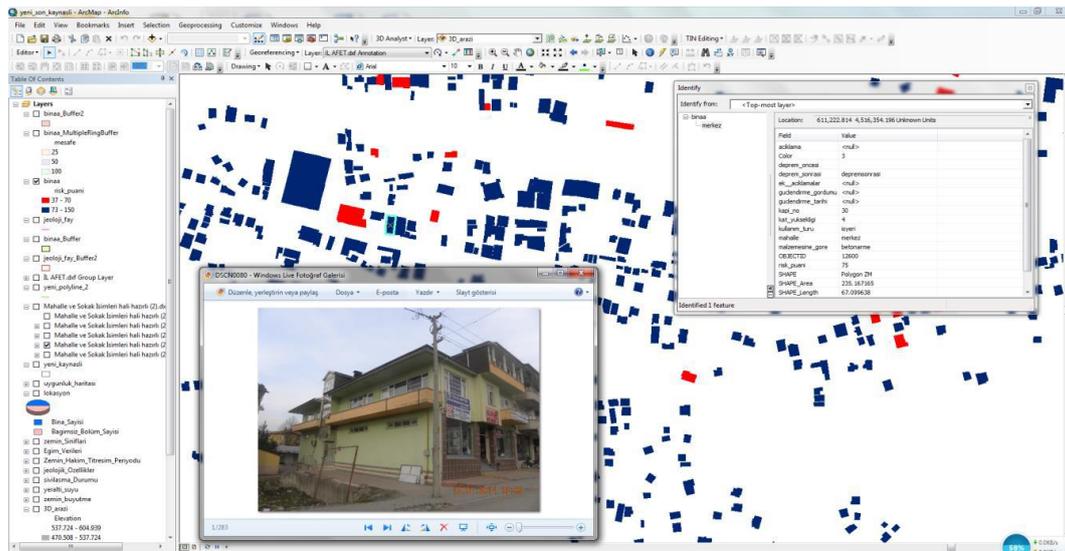
Figure 3. Building information obtained by street screening transferred to the ArcGIS database

For this study, first, the raster suitability maps in the geological-geotechnical survey reports prepared by the ZETA engineering project [16] were digitized using the ArcGIS program. The street screening method was used in the creation of the building inventory. The street screening procedure developed by Sucuoğlu (2007) [17] is a fast method of providing information about the strength and ability of buildings to withstand earthquakes by evaluating the negative parameters and assigning earthquake scores to the buildings according to these evaluations. In this way, it is possible to classify the surveyed buildings as high risk or low risk. In the study, the building information obtained via street screening was entered into the ArcGIS database and a risk map was created (Fig. 3).

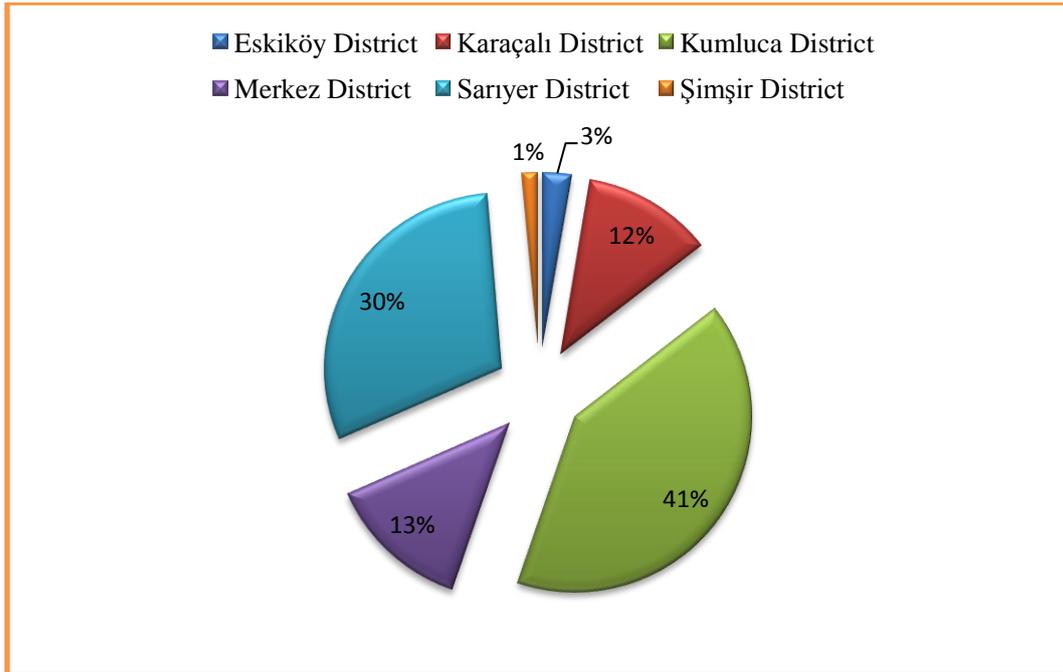
Figure 4. High-risk building rates according to district

According to the building earthquake scores, the greatest proportion of high-risk buildings (41%) was found in Kumluca District. The district determined to have the lowest proportion of high-risk buildings (1%) was Şimşir. The increased risk levels of the districts may have been determined by the pre-earthquake concentration of the buildings. Especially in the area of Şimşir, low-level (1-2-storey) houses were common and construction after the earthquake adhered to technical guidelines, thus reducing the risk ratio. According to the number of floors and number of flats of those buildings determined as high-risk by their earthquake scores, the numbers of people at risk were found. Based on the knowledge that an average family in Turkey consists of four people according to TurkStat data, four people were calculated per flat. Consequently, a total of 76 high-risk buildings were found according to the risk scores, and the number of persons at risk in these buildings was determined to be 1028.

Inventory information was taken according to the Kaynaşlı Municipality 2112 building survey form. The buildings examined comprised around 90% of all the residences of the settlement. The reliability of the study results was increased by the high percentage of buildings examined. Building earthquake scores varied between 1 and 150 points. Using this method can help those who work on risk limits to determine low- or high-risk buildings. When the building earthquake score rises, the risk ratio decreases; however, when it falls, the risk ratio increases. In the study, the risk limit was determined as 70 points. In other words, buildings with a building earthquake score of less than 70 were identified as high-risk, whereas buildings with 70 points or more were identified as low-risk. Accordingly, the high-risk building rates were determined in the seven districts where the study was conducted (Fig. 4).

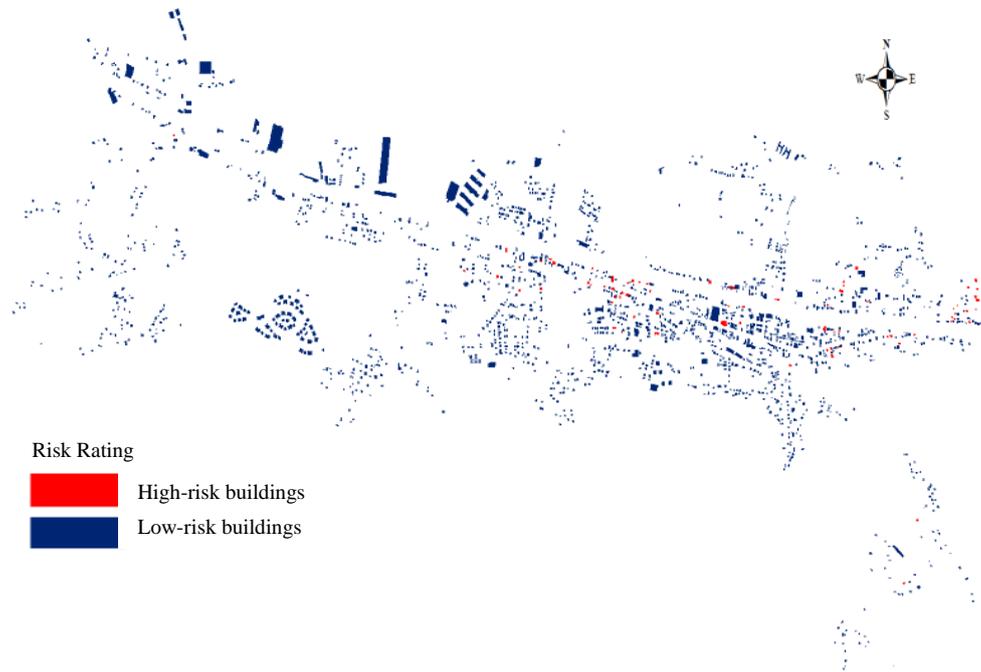
Figure 5. Risk map according to building earthquake scores obtained via street screening

After the conversion of the suitability map into numerical data, a data inventory was made of the construction dates (pre- and post-21 November 1999 earthquake) of the 2112 buildings surveyed by field application within the boundaries of the suitability map of Kaynaşlı. The building information was then transferred to the ArcGIS database and overlaid with the digitized suitability map. In this way, the area of the suitability map in which each building was located was determined according to the addresses, and the current situation of the settlement was evaluated in terms of risk (Fig. 5).

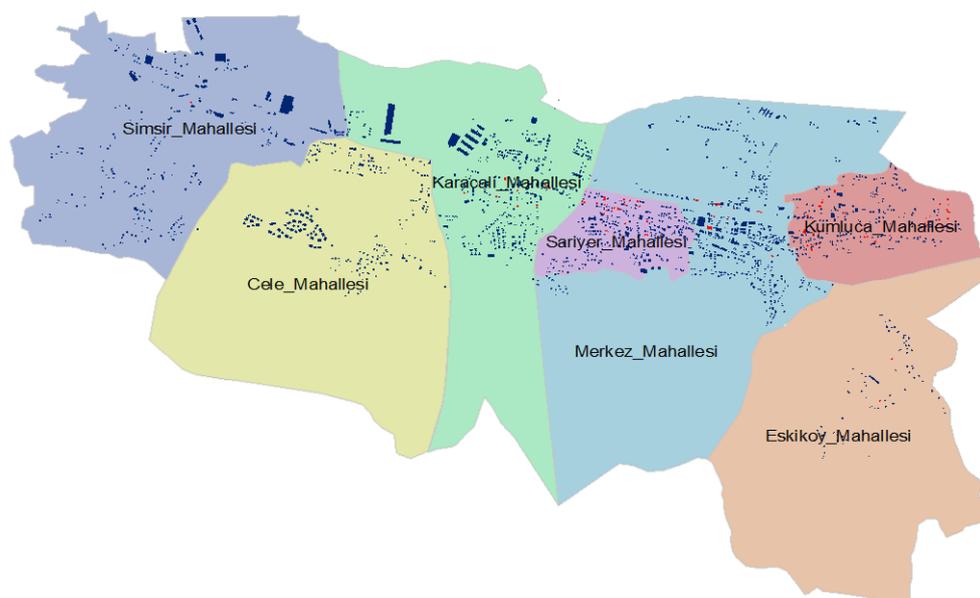
Figure 6. Kaynaşlı districts and the distribution of buildings within them

There are seven districts in Kaynaşlı: Şimsir, Çele, Karaçalı, Merkez, Sarıyer, Kumluca and Eskiköy. According to data obtained from Kaynaşlı Municipality, there are a total of 2211 buildings in these districts (Fig. 6). Of these buildings, 2112 were within the scope of the suitability study and their inventory data were obtained and analyzed in the ArcGIS program.

On the suitability map (Fig. 6) there are three probable natural disaster risk areas shown for the residential districts. The first one is the 6.5 km North Anatolian Fault Line passing through central Kaynaşlı and extending along in an east-west direction. Geological and geotechnical surveys have reported the fault line. The fault line and the 20 m on either side designated as a buffer zone have been evaluated as an unsuitable area on the suitability map. The second area evaluated as an unsuitable area is the flooding area, comprising the 10-m buffer zones on either side of Asar Creek, which passes through and extends to the northwest of the residential areas in Kaynaşlı. The third is the landslide area southeast of the residential districts. These three risk areas were evaluated as unsuitable on the suitability map. During the field applications of the study, the information obtained on the buildings was compared by overlaying the building data in suitability terms using the ArcGIS program. Buildings on fault lines, in flood risk areas, and in landslide areas were evaluated as being in disaster risk areas. In Table 5, which was created based on the suitability map, the distribution of buildings in all districts can be seen.

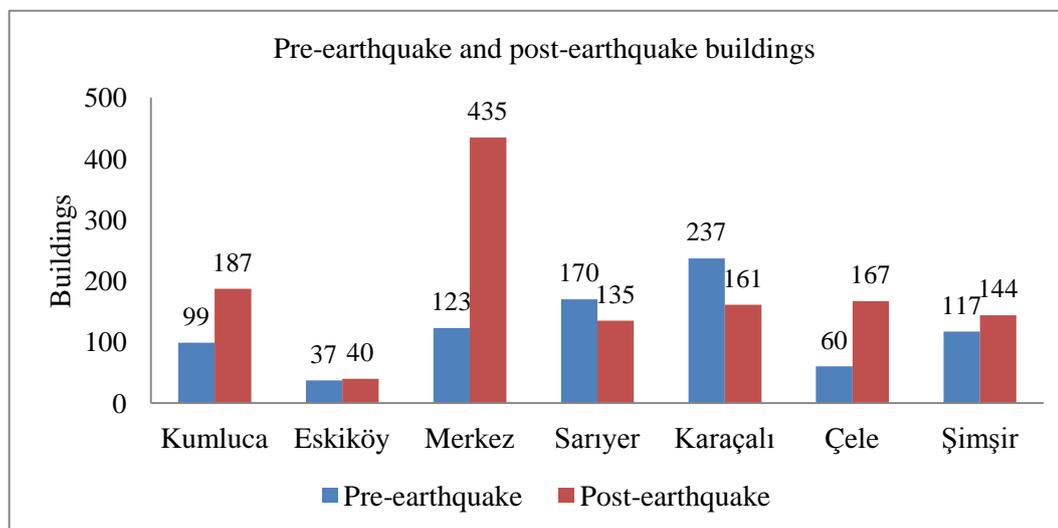
The pre-earthquake and post-earthquake distribution of buildings in all the districts of Kaynaşlı are illustrated graphically in Figure 7, which shows that the majority of pre-earthquake buildings were constructed in Karaçalı (237) and the majority constructed post-earthquake were in Merkez. The reason for the existence of many pre-earthquake buildings in Karaçalı is that fewer buildings there were damaged during the earthquake. When Karaçalı was structurally analyzed, it was seen that most of the buildings had a garden layout structure (discrete layout structure) and were built in the traditional style, having only one or two floors. Therefore, the

earthquake damage risk was low. However, in Merkez, the buildings of four or five floors were in adjacent layout and generally built in non-compliance with proper construction techniques and thus, had increased risk of damage in terms of earthquake suitability. As a result, during the 12 November earthquake, the greatest numbers of heavily damaged or destroyed buildings were located in the Merkez district of Kaynaşlı.

Figure 7. Distribution of pre- and post-earthquake buildings in the Kaynaşlı districts

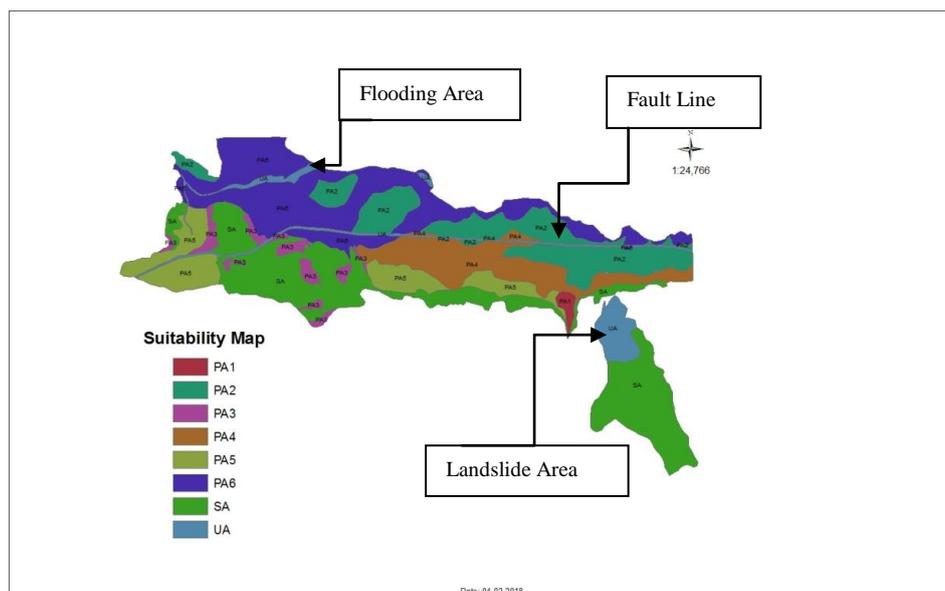
The Kaynaşlı building inventory information as per the suitability map (Fig. 8) was determined according to field work. Of the buildings placed on the suitability map, 78% (1654 buildings) are located in precautionary areas, whereas 19% (399 buildings) are in suitable areas.

Figure 8. Digitized version of the raster suitability map (SA: suitable areas, UA: unsuitable areas, PA1-PA6: Precautionary Areas1-6)

Suitable Areas (SAs): Within the study area, except for earthquake situations, these do not bear any natural disaster hazard potential, any geological or geotechnical features or any engineering problems that could affect settlement suitability; these areas should be considered suitable for building construction with no further action needed.

Precautionary Areas (PAs): Within the study area, due to natural disaster hazards and/or geological-geotechnical properties, specific measures need to be taken that may affect settlement suitability in these areas before and/or during construction. The details of recommended measures, their reasons and precautions are given in the subsections.

Unsuitable Areas (UAs): Within the study area, due to natural disaster hazards and/or geotechnical problems, laws and similar reasons, or for economic or technical reasons, these are unsuitable areas. Therefore, they should not be considered as construction sites for any purpose, even if appropriate measures are taken. Explanations for designating these areas as UAs are clearly stated in the subsections.

The 59 buildings located in unsuitable areas account for 3% of the total number of buildings, with 18 of these constructed pre-earthquake and 41 post-earthquake. This situation indicates that post-earthquake building construction was carried out in unsuitable areas without referencing the suitability maps.
